CASE HISTORY NO. 2-7

**COVERING AND SEEDING COAL REFUSE PILE**

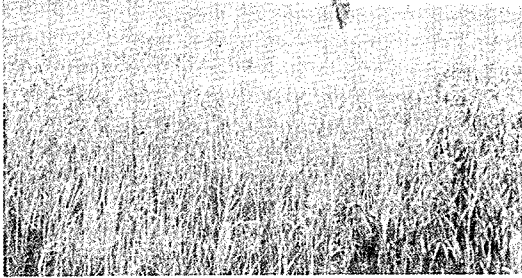
*Vegetative cover established on covered refuse pile to minimize erosion.*

**DESCRIPTION:** Old refuse pile in valley, compacted and graded on 23.2 acres.  
Cost of covering 23.2 acres of coal refuse with average of 3 ft.  
of overburden materials and soil:

The spoil and soil used for covering the refuse pile were available immediately adjacent to the refuse dump which reduced the costs of earth moving. The covering material was moved with a self-propelled scraper pan and leveled off with a road maintainer. The covering material was native acid soil of sandstone origin and spoil. It was heavily limed with a lime-spreader truck, fertilized and drill-seeded to Balboa rye and Kentucky 31 fescue. Later on in the late winter it was also seeded to Korean lespedeza.
